SPECIAL COUNCIL MEETING
CITY OF CROSSLAKE
THURSDAY, JULY 30, 2020
9:00 A.M. – CITY HALL

Re: Crosslake Emergency Services Center – Moisture Damage Review
37028 So Rd 66
Crosslake, MN
Enc. Project No.: 20-7584

At your request, Encompass has performed a review of reported moisture damage to the Crosslake Emergency Services Center. This assessment is limited in scope to specific locations of moisture damage as reported by City representatives. This report provides a summary of our findings and recommendations for repair.

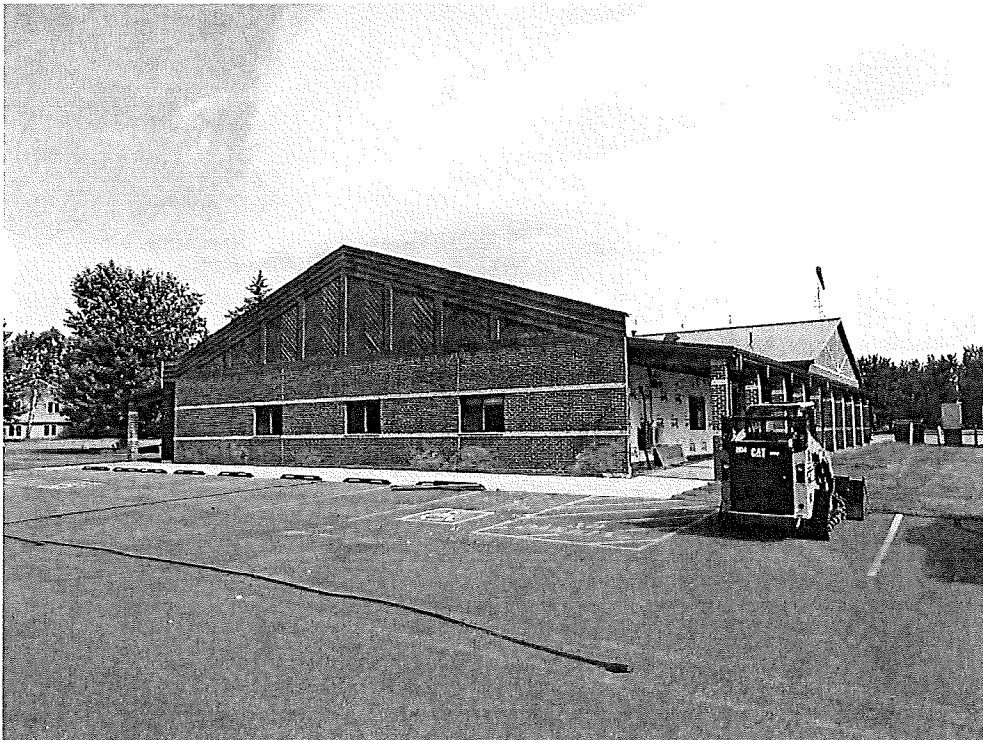
Photograph 2: South Elevation

- 2.1.2. The exterior of the South wall is clad with brick for the lower 12 feet and then transitions to cedar siding at the gable above (Photo #2). Various efflorescence staining is present on the base of the brick masonry, in patterns consistent with overspray from a previous sprinkler system. No through-wall flashing is present along the base of the wall.

- 3.3. Remove and replace brick cladding at South elevation. Replacement of the brick is necessary to address underlying sheathing damage. New brick should have wall base through-wall flashing, a continuous weather barrier, and have cap flashing that is sloped and integrated with the weather barrier behind the new siding above.

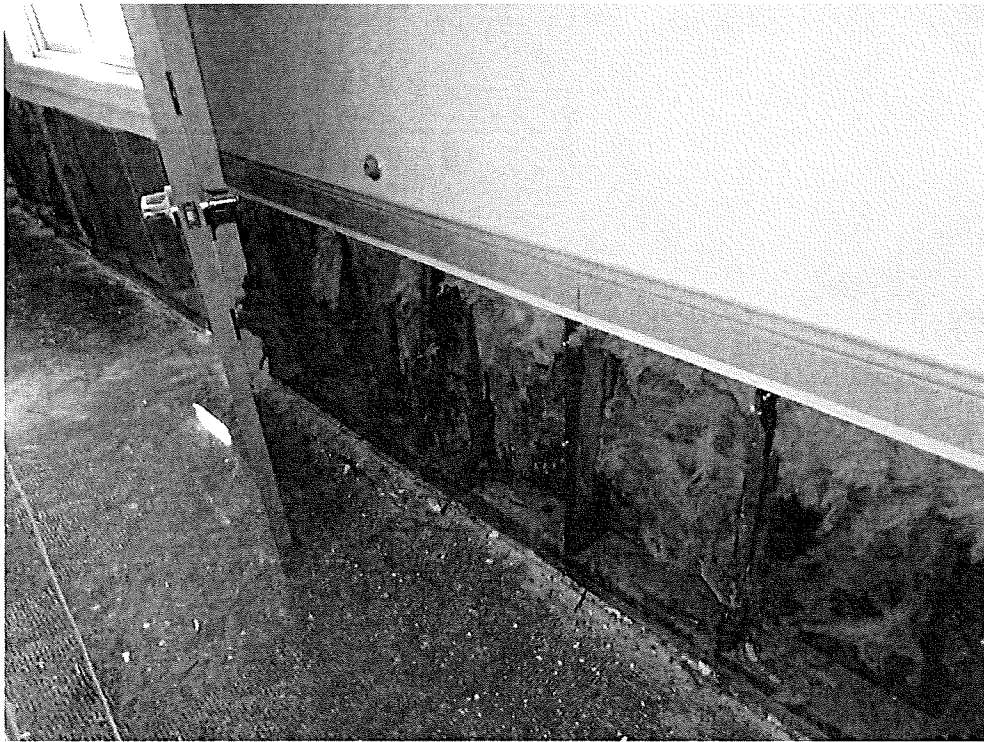
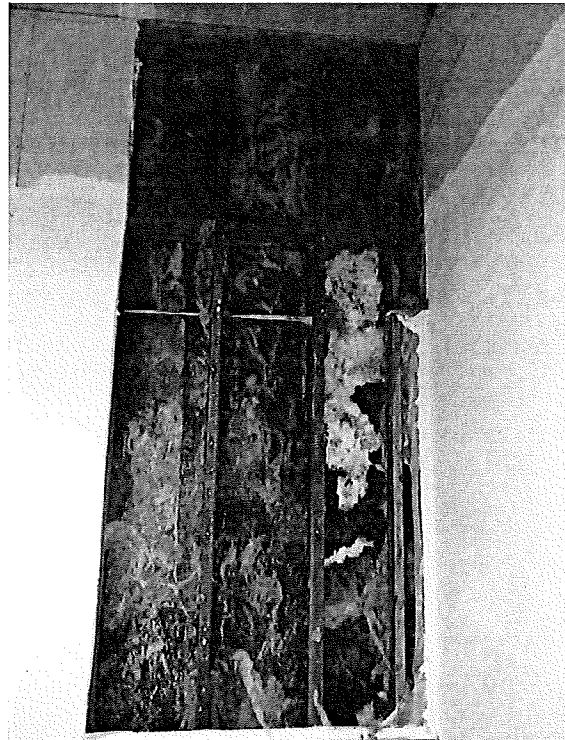
- 2.1.1. The City reported finding rusted file cabinets that were placed along the south wall of the building. During the renovations, workers removed sections of wall board and discovered water damaged sheathing (Photos #3-4). Mold-like growth was present on the interior side of the sheathing. Water damaged and deteriorated studs were present, as was damaged sheathing along the wall base.

The damage was sporadic throughout the wall but was most severe near the SW corner.

- 2.1.5. It is our opinion that the damage to wall sheathing and corrosion of metal cabinets placed adjacent to the wall is the result of the following original construction related deficiencies:

- Metal flashing atop the brick that does not drain water away, combined with holes in the flashing. These conditions allow water to bypass the flashing and migrate behind the brick.

- Incorrect installation of Tyvek that does not lap over the vertical leg of the metal flashing. This condition allows water that enters behind the wood siding to bypass the metal flashing and migrate behind the brick.

- The lack of an air space and wall base through-wall flashing. These conditions allow for an accumulation of moisture behind the brick that can diffuse

through the Tyvek and/or migrate through fastener holes and onto the wall sheathing.

- Prolonged moisture in the wall likely seeped onto the floor and into the carpet where it came in contact with the metal cabinets.

Photograph 3: South Wall

Photograph 4: South Wall at West corner

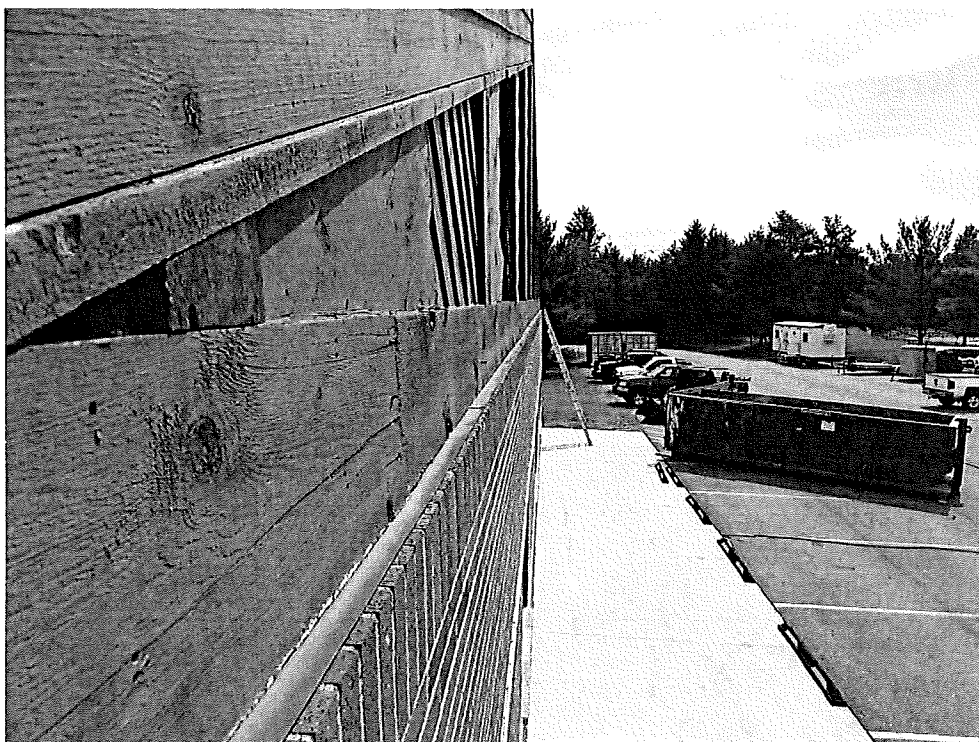
- 2.1.3. At the transition from brick to wood siding, an "L" shaped metal flashing is present (Photo #5). The flashing is installed with little or no slope and in some locations is back-sloped to the building. Deteriorated sealant is present below the flashing. Gaps and openings are present at the SW corner, aligning with the most severe interior damage (Photo #6).

- 2.1.4. Tyvek weather barrier is present behind the siding, which was visible through gaps in the siding, and extends behind the brick. The Tyvek does not lap over the vertical leg of the metal flashing, but rather extends behind. Where interior sheathing was deteriorated, Tyvek was visible behind the brick, little or no air space was present between the brick and wall sheathing.

Photograph 5: Flashing atop brick at South Elevation

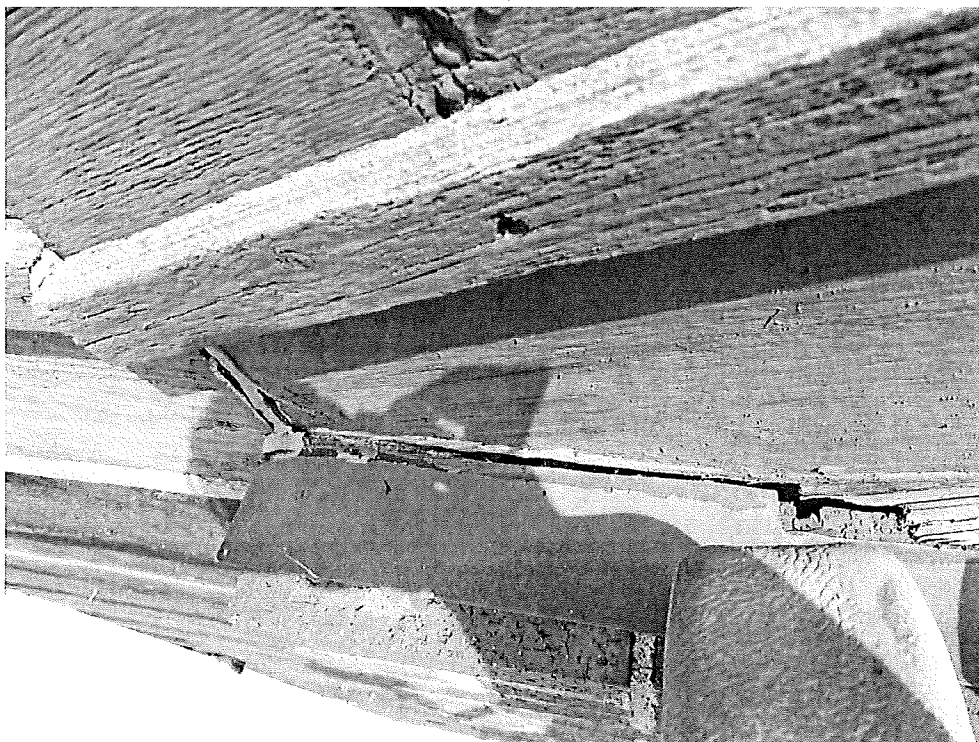
Photograph 6: Flashing atop brick at South Elevation (SW Corner)

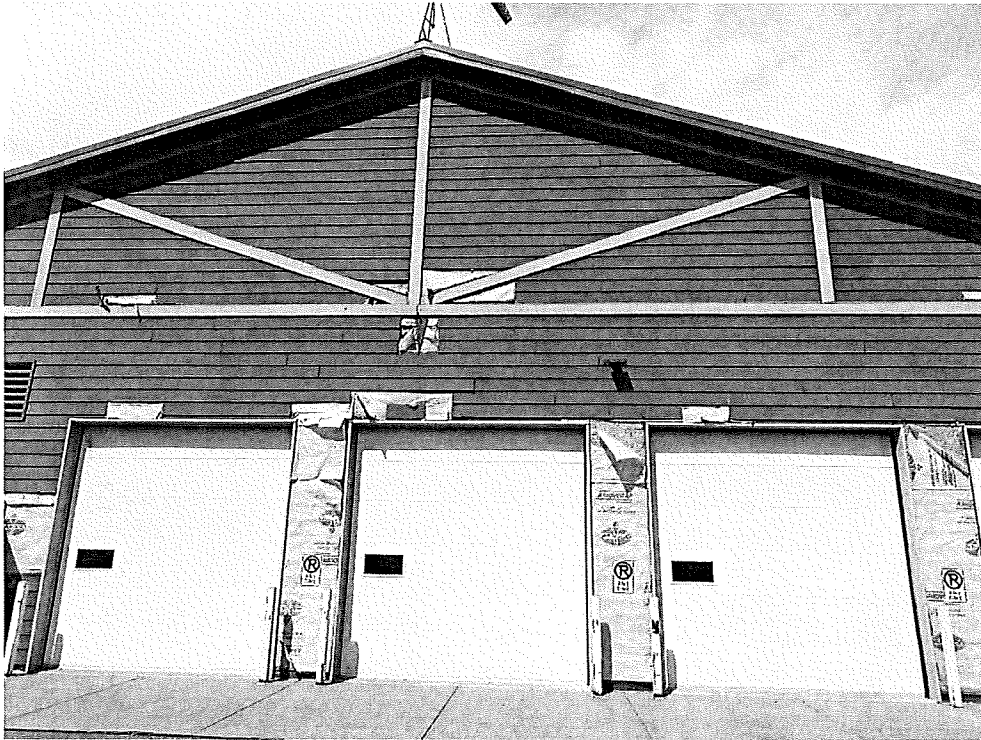
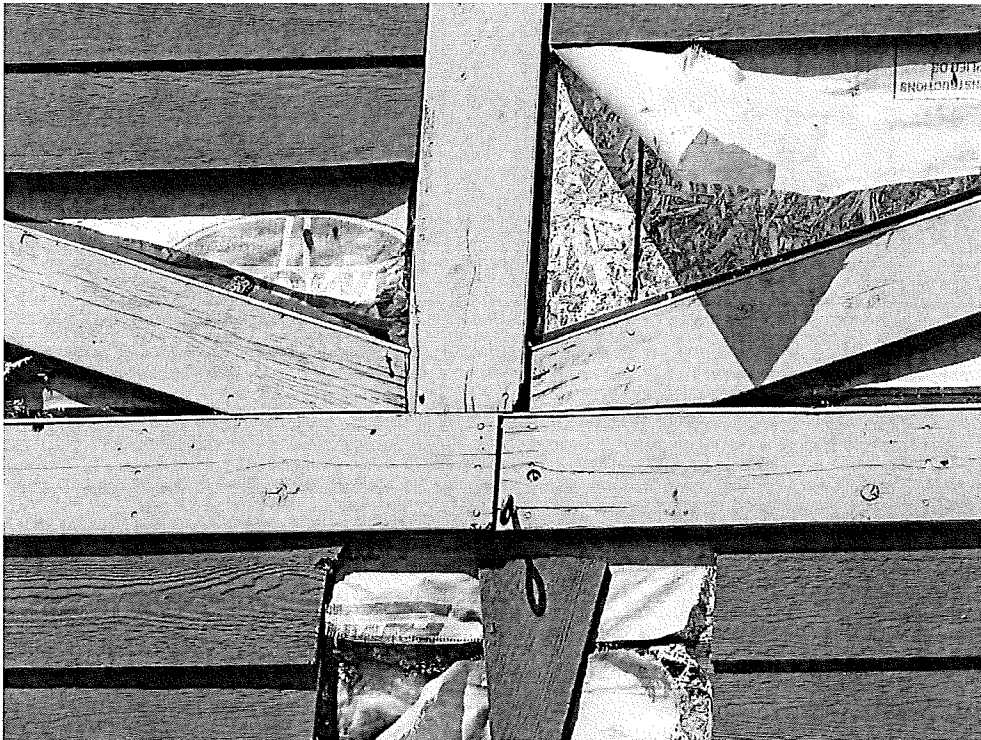
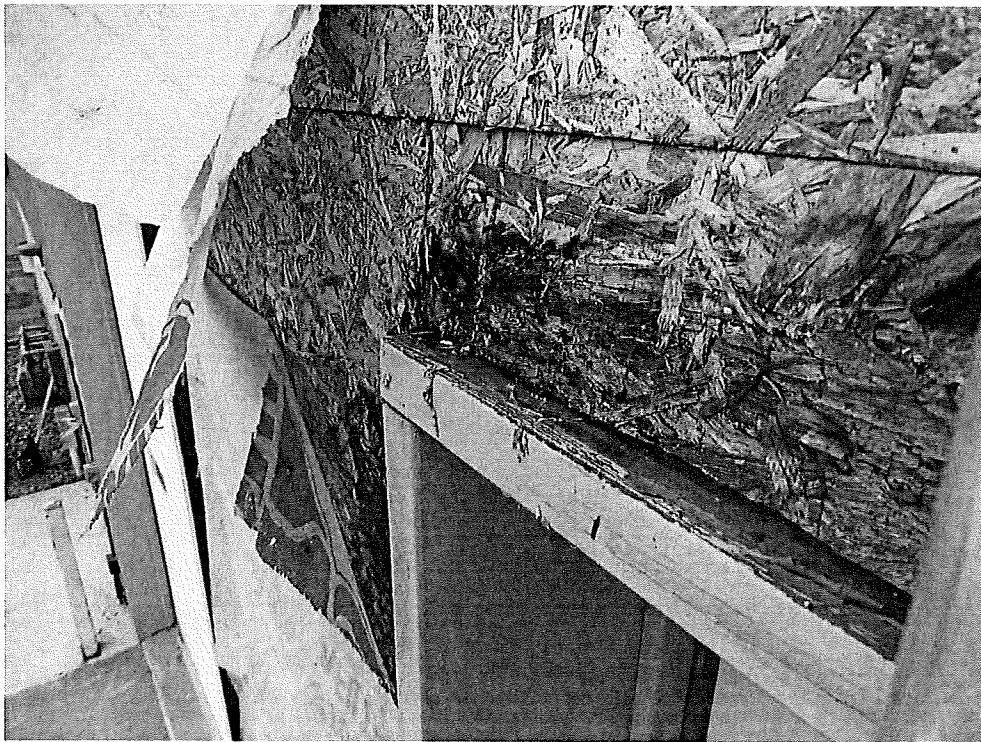
2.2.2. Water damaged siding was present immediately above the garage doors and below decorative trim located several feet above the doors (Photos #7-9). At the trim, diagonal metal flashing converged and directed water behind the siding and trim to the door below. At the head of the door, a flat oriented 2x6 is present that restricted water from draining out from behind the siding. Deterioration of sheathing, siding and trim, and wood headers is present at each of the doors.

2.2.3. Deterioration is attributed to original construction detailing that directed water behind the siding and then restricted its exiting. It is our opinion that this damage has been occurring slowly since original siding installation.

Photograph 7: East Elevation Garage

Photograph 8: East Elevation Garage – Trim Intersection

Photograph 9: East Elevation Garage – Door Head

- 3.1. The following are general recommendations and are intended to address moisture intrusion concerns as reported by onsite persons.
- 3.2. Remove and replace all lap siding. The existing underlying details and moisture management is prone to moisture intrusion and deterioration. In order to address moisture leaks and underlying damage, it is recommended that all siding, flashing, and weather barriers be replaced.

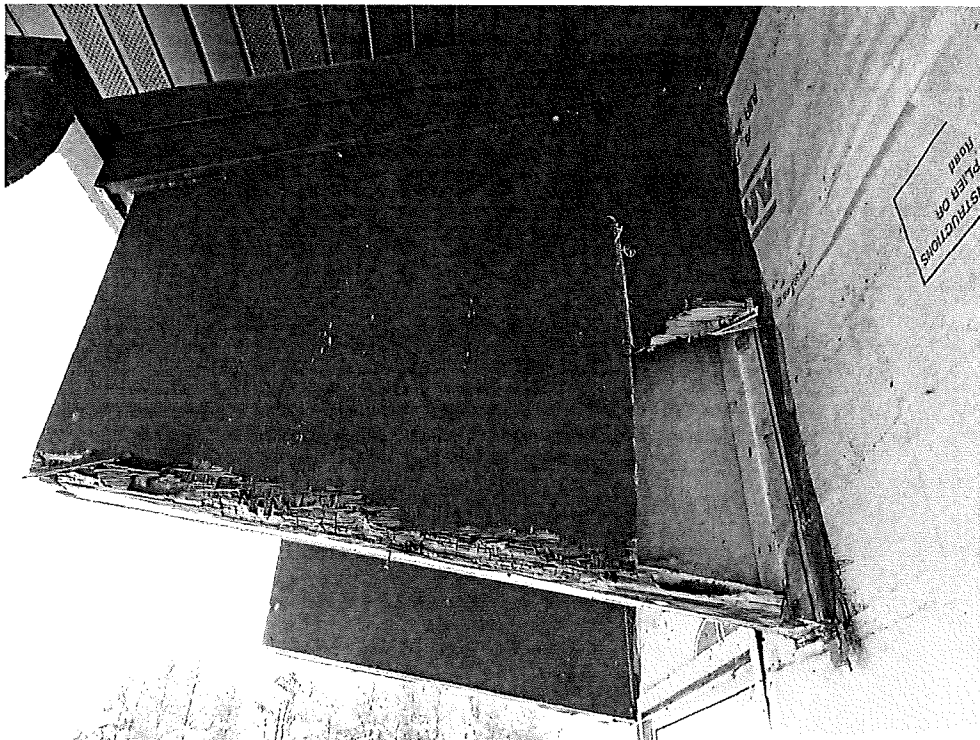
2.3.1. Moisture damaged and deteriorated siding was observed at the base of canopy roof walls. We understand these roofs were added to address sliding snow concerns from the main roof. Siding was removed to evaluate underlying conditions (Photo #11).

2.3.2. Water damaged siding and 2x6 trim was present at the base of the side walls. Deterioration is attributed to original construction detailing that directed water against the siding. It is our opinion that this damage has been occurring slowly since original siding installation. Furthermore, no weather barrier or counter flashing was present.

Photograph 10: Canopy at service door

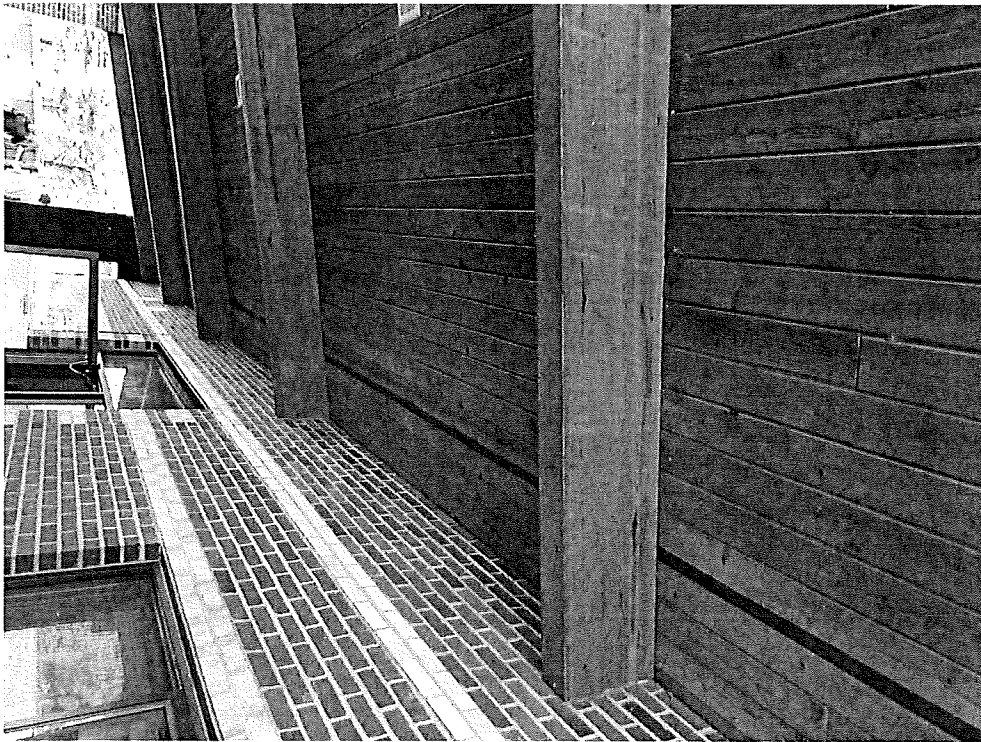
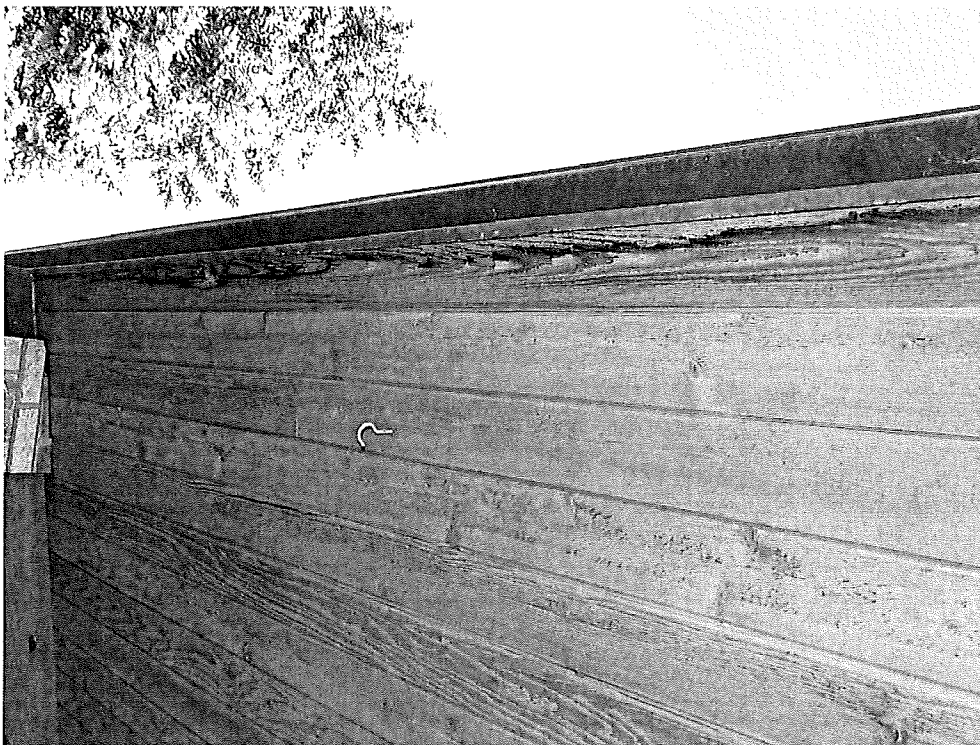
2.4.1. Employees reported water dripping from the large east and west soffits during periods of cold weather. The soffit is approximately 10 feet wide and is constructed of tongue and groove pine affixed to roof framing. A 2" wide strip vent is present against the building wall (Photos #12-13). The eave vents were

partially clogged with debris. Dried water stains are present along the outer edge of the soffit along both elevations.

- Air chutes that are incomplete, compressed, and displaced. This condition restricts the flow of fresh air into the attic.
- Soffit vents that are blocked with debris and not placed along the outer edge of the soffit. The current placement results in the truss space between the eave and existing soffit vent to be unventilated and prone to condensation.

Photograph 11: West Soffit

Photograph 12: West Soffit at Eave

- 3.4. Replace Attic Ventilation – Remove and replace all air chutes in the attic with new, full width chutes in each truss space. Remove and replace tongue and groove soffits with metal perforated soffits. Supplement attic insulation to current code requirements, ensure that all ceiling penetrations/bypasses are sealed to the vapor barrier.

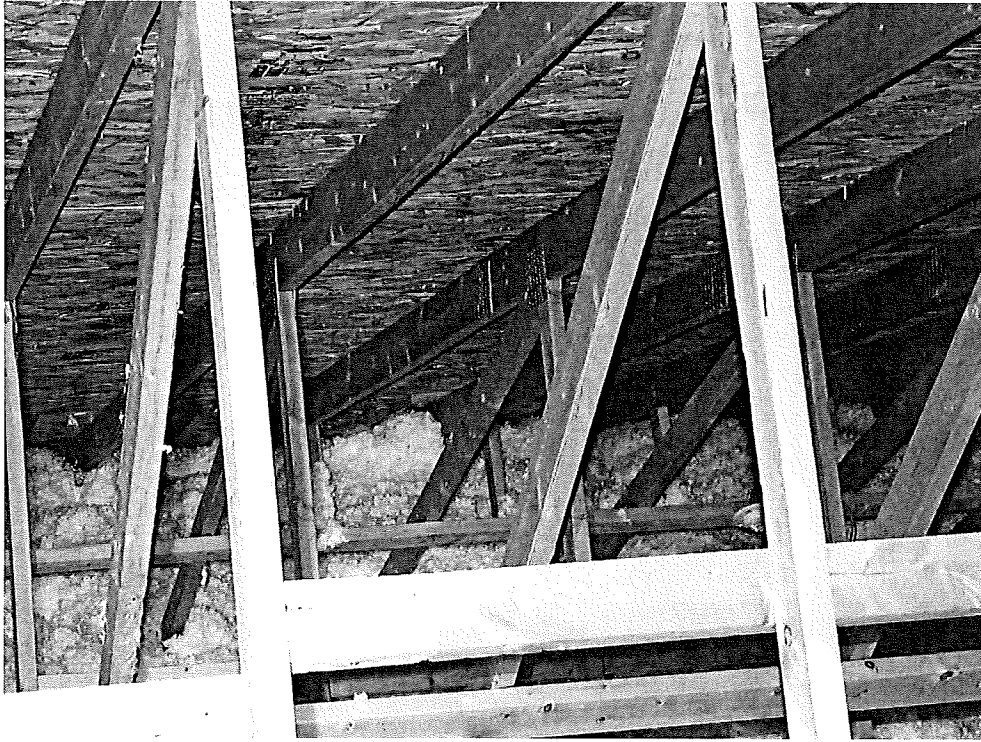
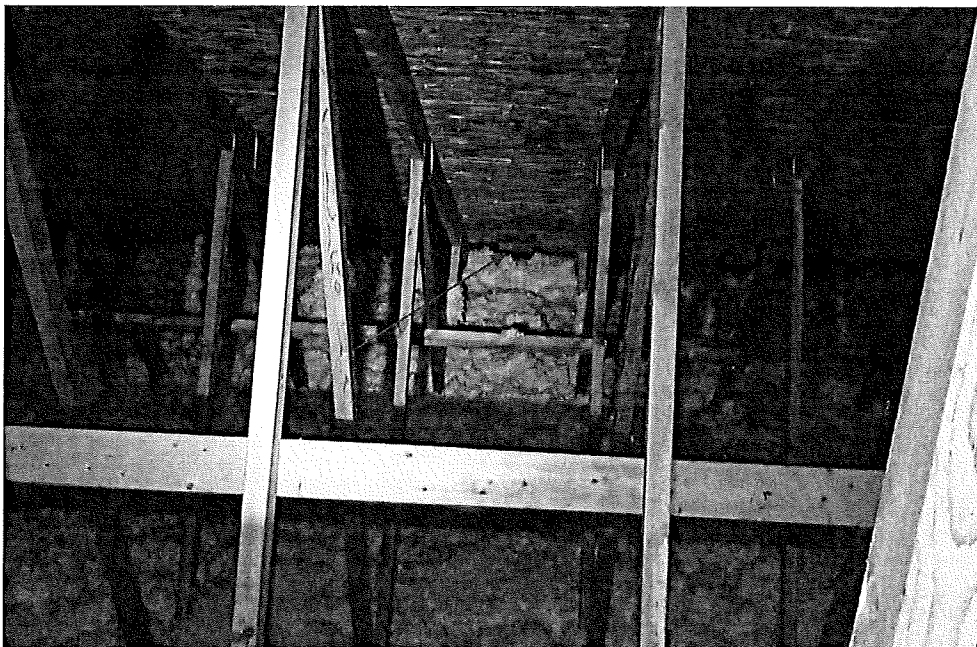
2.4.3. Review of the attic noted that the wood truss spaces were filled with approximately 12" of blown fiberglass. Air chutes are present along the eaves; however, the chutes are displaced, compressed, and are not the full width of the truss space (Photos #13-14). A continuous ridge vent is present.

Photograph 13: Partial Air Chute

Photograph 14: Partial Air Chute

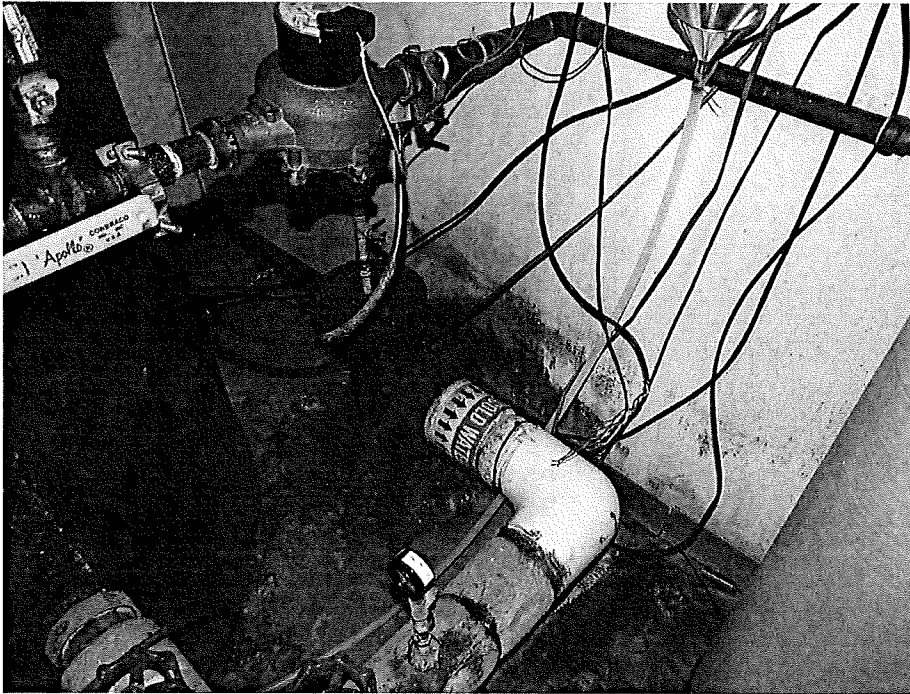
2.5.2. Mold-like growth on walls of the water storage tank room (Photo #15). Discoloration was present on the gypsum walls. Moisture was present on the floor and water pipes were sweating. It is our opinion that the growth is the result of water exposure and high humidity in the room over a prolonged period.

Photograph 15: Water Storage Tank Room

The water tank storage room that has mold-like growth on the walls is attributed to sweating of the pipes and humidity in the room.

- 3.5. Install FRP board on walls in the water storage tank room
- 3.6. Abate organic growth on the ceiling in the janitorial space.
- 3.7. Abate organic growth on wall base in compressor room, install FRP board.

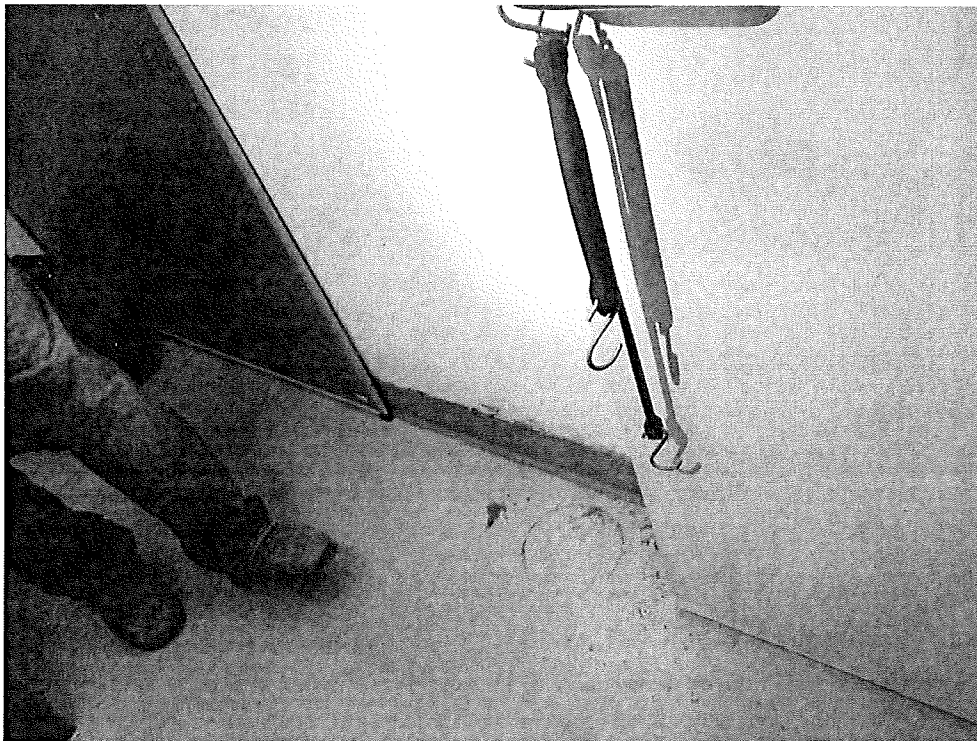
2.5.3. Mold-like growth on the ceiling of the compressor room. A small area of growth was present on the ceiling. The area aligns below a vacant storage area above. Minor old water stains are present on the storage area floor above, however the specific age and source of the stains is unclear. A small, mold-like growth was also present on the base of the west wall, adjoining the slop-sink room. The source of this is unclear, though this may be attributed to poor air circulation and equipment being placed against the wall as well as moisture from the sink area adjacent to this wall (Photo #16).

Photograph 16: Compressor Room

The mold-like growth in the compressor room ceiling appears to be related to something that was leaking in the storage room above it. Additionally, it is believed that the small area affected along the vinyl base is a result of items stored too close to the wall which didn't allow for proper airflow.

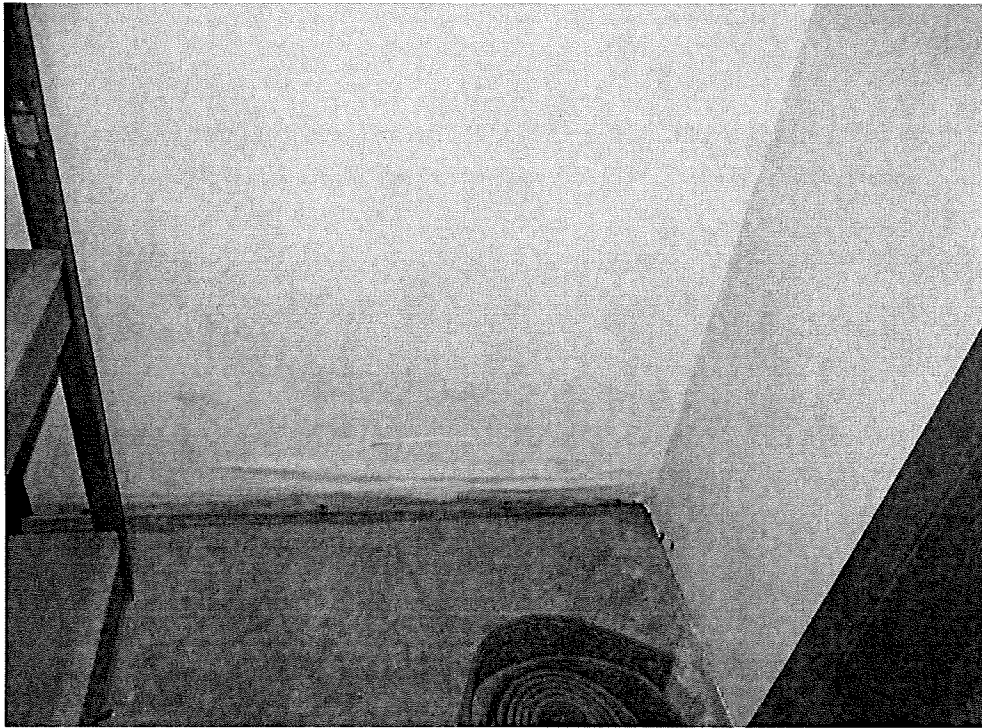
2.5.4. Storage Closet Adjacent (South of) to Slop Sink Room. Moisture staining was present on the base of the wall in a storage closet (Photo #17). This moisture is

attributed to residual moisture from the sink area that pools and runs under the floor plate into the closet area.

Photograph 17: Storage Area South of Slop Sink

Day Room storage closet drywall damage is the result of water that has pooled under the sink and flowed under the floor plate into the closet.

- 3.8. Abate organic growth on wall below the slop sink and the closet to the south.
