AGENDA  
PUBLIC WORKS COMMISSION  
CITY OF CROSSLAKE  
MONDAY, MARCH 4, 2024  
4:00 P.M. – CITY HALL

RE: PROPOSAL: Milinda Shores Bridge (#L4044) Wingwall Repairs

2023 ROUTINE  
BRIDGE INSPECTION REPORT

**BRIDGE # 18533**  
**DREAM ISLAND RD over CHANNEL LITTLE PINE LK**

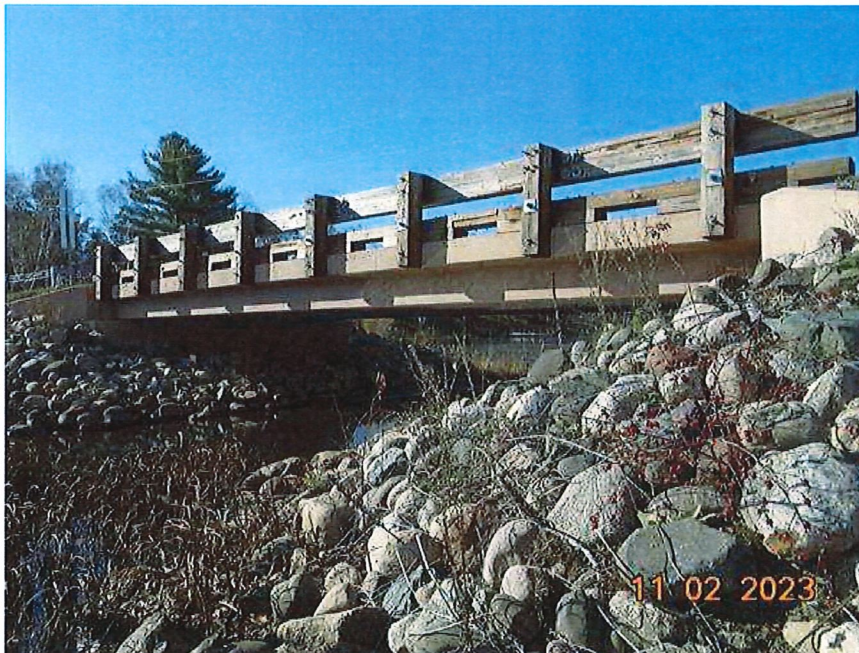
ELEM NBR	ELEMENT NAME	REPORT TYPE	INSP. DATE	QUANTITY	QTY CS 1	QTY CS 2	QTY CS 3	QTY CS 4
12	Reinforced Concrete Deck	Routine	11/02/2023	1060 SF	1060	0	0	0
		Routine	11/03/2021	1060 SF	1060	0	0	0
Notes: 11/02/2023: There are some minor transverse random cracks with minor leaching visible on the side of the deck and minor longitudinal cracks at deck ends. There are minor longitudinal cracks visible on the bottom of the deck following the rebar chairs. None of the cracks visible have any leaching or efflorescence. 11/03/2021: There are minor longitudinal cracks visible on the bottom of the deck following the rebar chairs. None of the cracks visible have any leaching or efflorescence. 11/05/2019: Like new.								
510 -	Wearing Surfaces	Routine	11/02/2023	963 SF	963	0	0	0
		Routine	11/03/2021	963 SF	963	0	0	0
Notes: 11/02/2023: The surface of the deck has minor unsealed transverse cracks across the deck and minor longitudinal cracks, 10' to 15' long, located at the roadway centerline over the abutments at both ends of the deck. 11/03/2021: The surface of the deck has minor longitudinal cracks, 10' to 15' long, located at the roadway centerline over the abutments at both ends of the deck. 11/05/2019: Like new.

109	Prestressed Concrete Open Girder/Beam	Routine	11/02/2023	189 LF	189	0	0	0
		Routine	11/03/2021	189 LF	189	0	0	0
Notes: 11/02/2023: No notable defects or deterioration.								
215	Reinforced Concrete Abutment	Routine	11/02/2023	73 LF	73	0	0	0
		Routine	11/03/2021	73 LF	73	0	0	0
Notes: 11/02/2023: No notable defects or deterioration.								
332	Timber Bridge Railing	Routine	11/02/2023	99 LF	83	16	0	0
		Routine	11/03/2021	99 LF	99	0	0	0
Notes: 11/02/2023: All of the rail posts have checks or shakes that penetrates 5% to 50% of the post thickness. 11/03/2021: Timber railing is in good condition. All connections are in place and functional. Timber railing does in fact measure 99 feet!								
800	Critical Deficiencies or Safety Hazards	Routine	11/02/2023	1 EA	1	0	0	0
		Routine	11/03/2021	1 EA	1	0	0	0
822	Bituminous Approach Roadway	Routine	11/02/2023	2 EA	0	2	0	0
		Routine	11/03/2021	2 EA	0	2	0	0
Notes: 11/02/2023 - 11/03/2021: Minor settlement has occurred at the abutments in the approaches. There is a bituminous patch present at the deck joint to prevent plows from catching the concrete deck. 11/05/2019: Approaches were paved spring 2018.

- Small minor deck cracks were noted in the fall 2023 inspection. These cracks should be epoxy sealed to keep water and salt from penetrating to the steel deck reinforcement. Recommend placing this bridge on a schedule with the Sunset Island bridge and seal every 5 years. Epoxy sealing should be considered normal bridge maintenance and for this bridge repeated every 5 years.

- The approaches were found in good condition during the fall bridge inspection however there are patches at the deck and roadway joint. This is typical for this bridge joint design. This settlement should be patched as needed to provide a smooth transition between the deck and roadway and joints should be sealed yearly to reduce the severity of any settlement occurring.

- Consideration may be given to sealing the tops of the railing and rail posts to protect the timber elements from moisture intrusion and extend the life of the railing. For more information, please contact this office.
